JD METALS TEST REPORT

UL 2218 IMPACT RESISTANCE TESTING OF TUFF-RIB ROOF PANELS

N8964.01-801-44 R0

Product Type: Metal Roof Panels Tuff-Rib

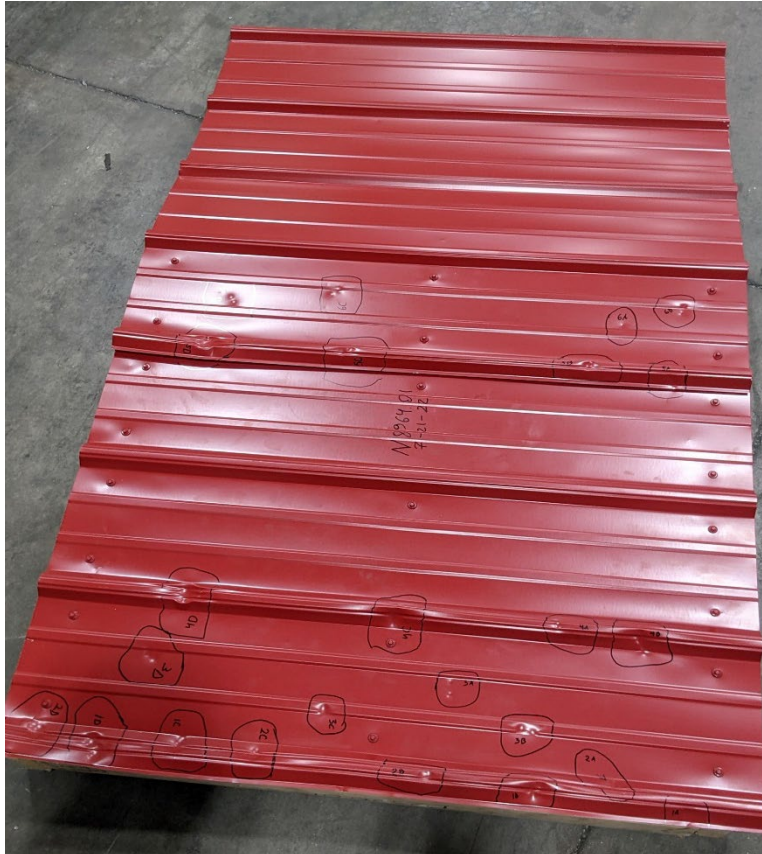
Photo No. 1
Test setup and overall impact locations.

Installation of the tested product was performed by Intertek. Panels were secured to deck with provided 1.70" screws with sealing washer; Fastening pattern followed from JD Metals drawing; 3 rows 17" apart.

The wood test deck was 3' wide x 3' high and constructed with 2x4 pine construction lumber at the perimeter with one stud located at the midspan. The test deck was covered with 15/32" thick plywood decking secured to the test deck with #6 x 1-5/8" screws located 2" from each end and on 6" centers.

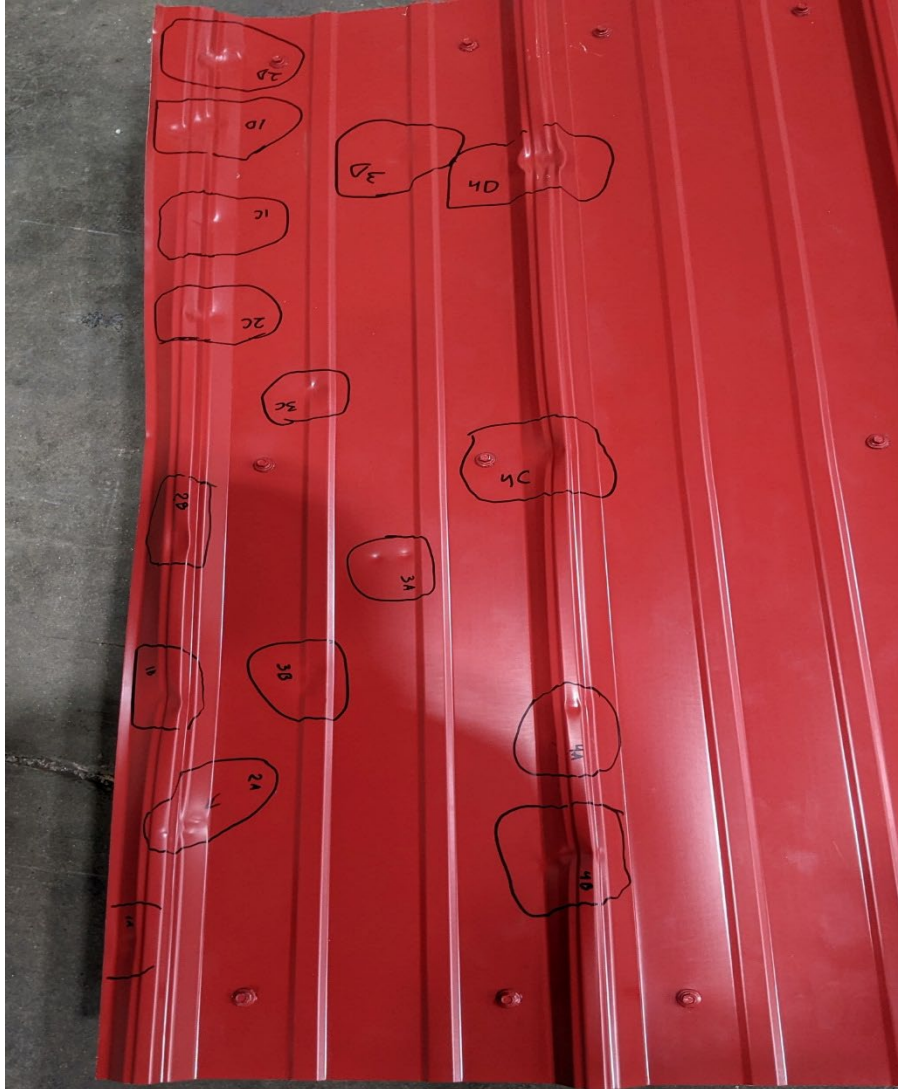
Photo No. 2
Impact locations detail
